SALMONID HABITAT LIMITING FACTORS ANALYSIS

CHAMBERS-CLOVER CREEK WATERSHED

WATER RESOURCE INVENTORY AREA

**Judy Runge
Marc Marcantonio
Monty Mahan
Pierce Conservation District**

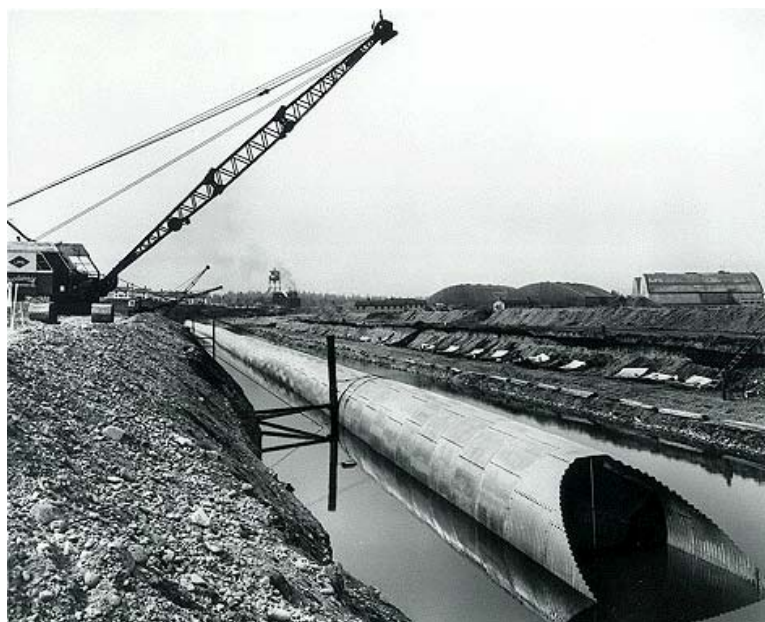
Figure 3: One of the 12 ft diameter pipes rolled in place in the McChord Airbase channel in 1939
(Photo from Tacoma Public Library, courtesy of Fred Tobiason)

A unique characteristic of this creek is that it is contained within a 0.6 mile long underground culvert below the runways at McChord Air Force Base before passing under the I-5 freeway.

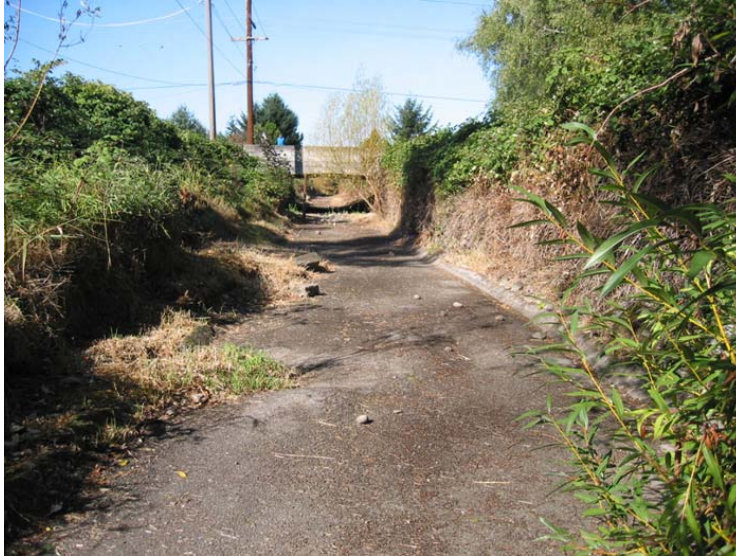
Figure 10: Clover Creek near C Street bridge, September 2002
(Photo by Pierce Conservation District)

A more severe problem is occurring in Clover Creek east of McChord AFB. During both 2001 and 2002, the creek has gone completely dry during the late summer months between 136th St. So. and Spanaway Loop Road, and also downstream to the marshy area east of the McChord culverts, locally referred to as the Schibig/Smith Marsh. In fact, the stream has been dry several times all the way to Steilacoom Lake, even with the added flow of water from Spanaway Creek (Tobiason, Pers. Comm., 2003).

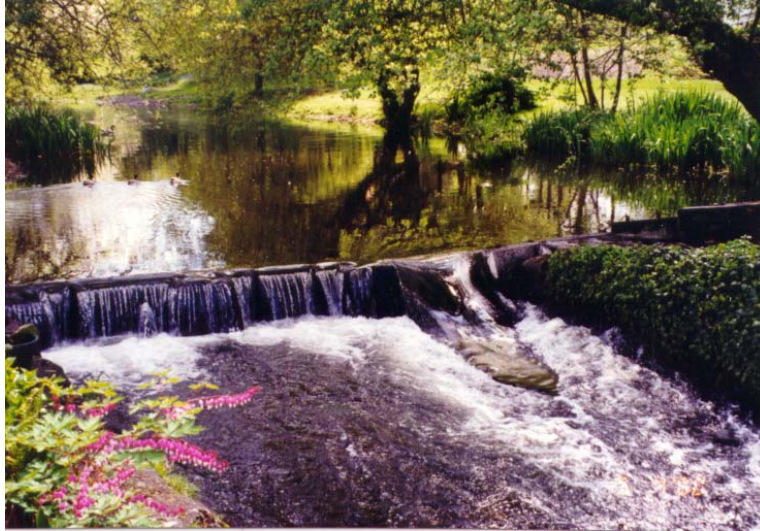
Figure 11: A dam created a pond and a barrier to fish
(Photo by Pierce Conservation District)

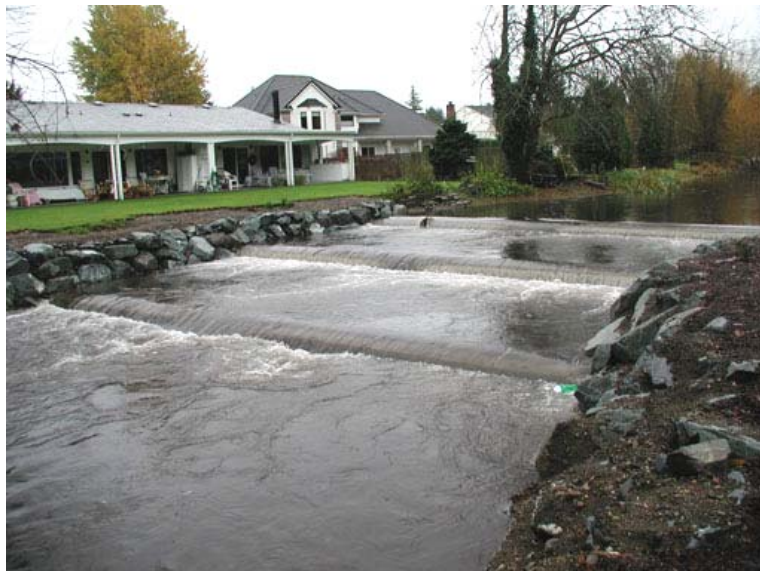
Figure 12: Weirs now provide access for migrating salmon
(Photo by Pierce Conservation District)

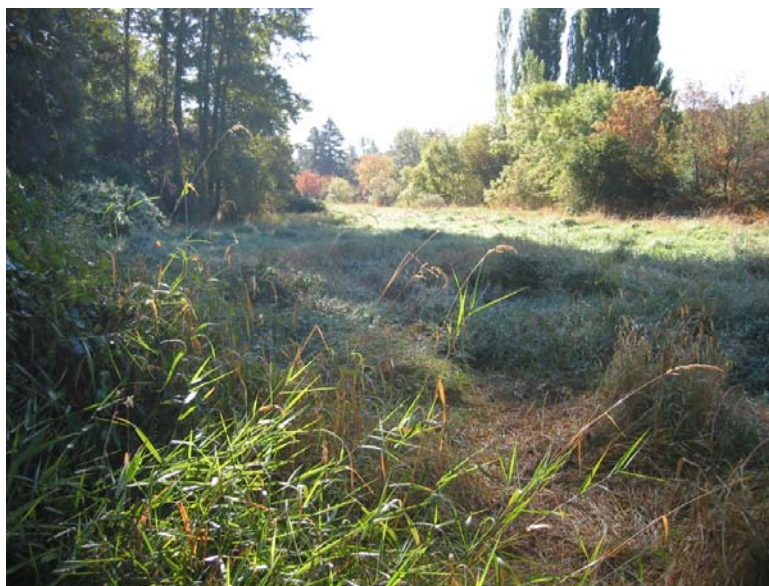
Figure 14: Reed canary grass chokes the stream channel
Photo taken on Clover Creek Reserve near 141st Street South.
(Photo by Pierce Conservation District)

The lack of woody stream bank vegetation has caused many problems in the watershed. The absence of shade increases stream water temperatures and promotes the establishment of invasive plant species such as elodea and reed canary grass. Both of the plant species have adverse effects on stream conditions by slowing flow, decreasing dissolved oxygen, and decreasing biological diversity in the riparian areas (PCD, 1998).

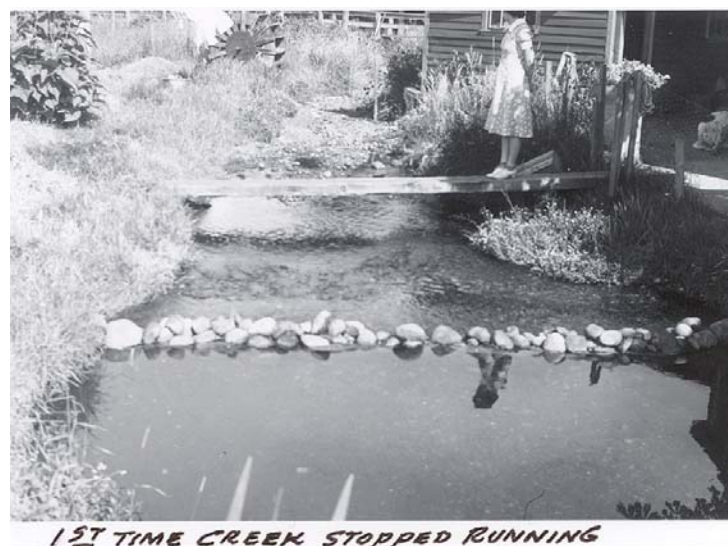
Figure 15: A view of Clover Creek, looking west
(Photo from the Tom Richards family, 1940; courtesy Fred Tobiason)

A study recently completed by Fred L. Tobiason suggests that Clover Creek was subject to perennial flows from the late 1880s to around 1940 (Tobiason 2003), whereas some earlier documents suggest that intermittent flows began in the late 1800s. An extensive series of interviews with residents along Clover Creek during the time period encompassing 1924-1940 showed that Clover Creek flowed continuously during that period. There were many eyewitness reports of significant steelhead and salmon runs (see Figure 13: Large salmon (reported as Coho) and trout caught in Clover Creek near Pacific Avenue in November, 1936.), as well as native and searun cutthroat. One of the residents, Tom Richards, documented the first time the creek stopped running in 1940 (Figure 15: A view of Clover Creek, looking west).

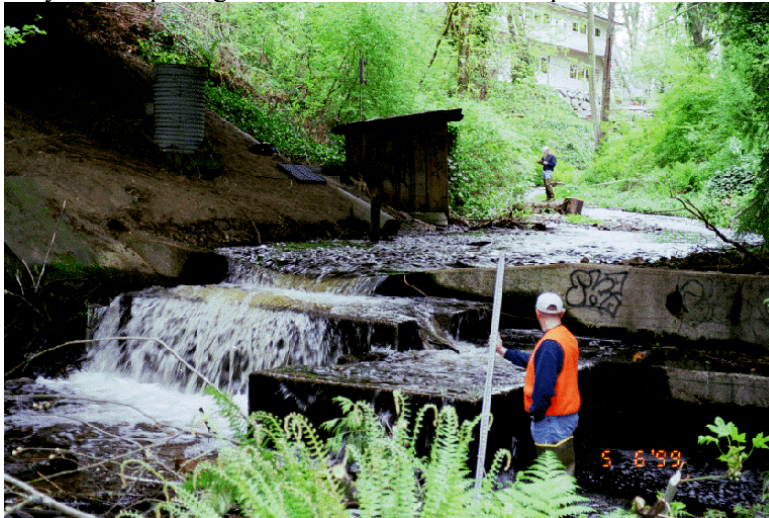
Figure 16: A barrier located immediately under 75th Street West
(Photo by Pierce Conservation District)

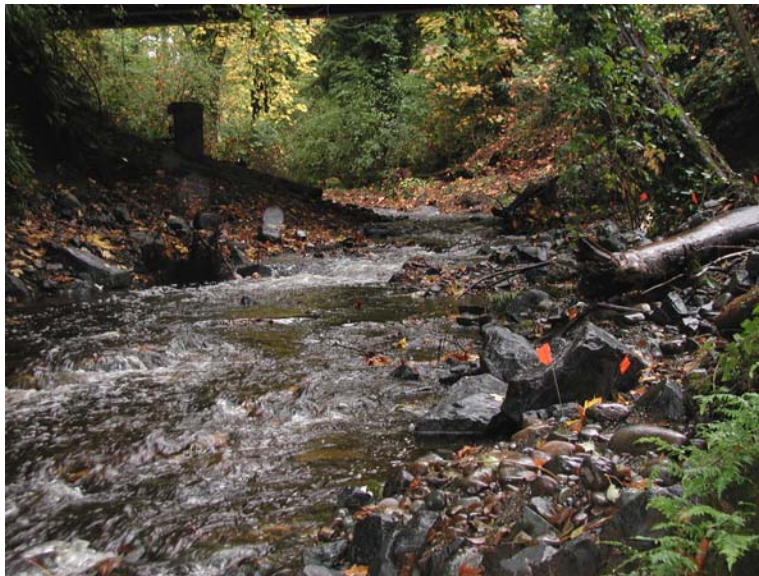
Figure 17: The barrier was removed and native plants placed along the banks
(Photo by Pierce Conservation District)

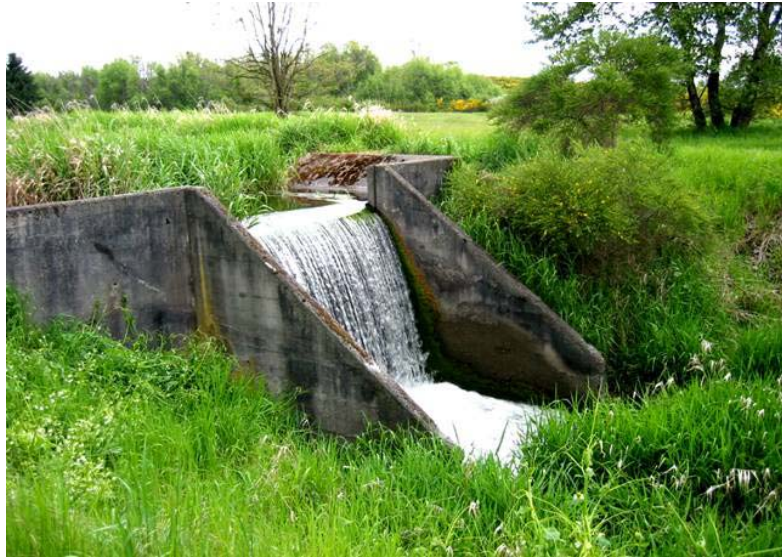
Figure 18: The concrete dam on Morey Creek
(Photo by Pierce Conservation District)

The TetraTech/KCM (2002) study for Pierce County also made note of a concrete weir at the downstream end of Morey Creek.

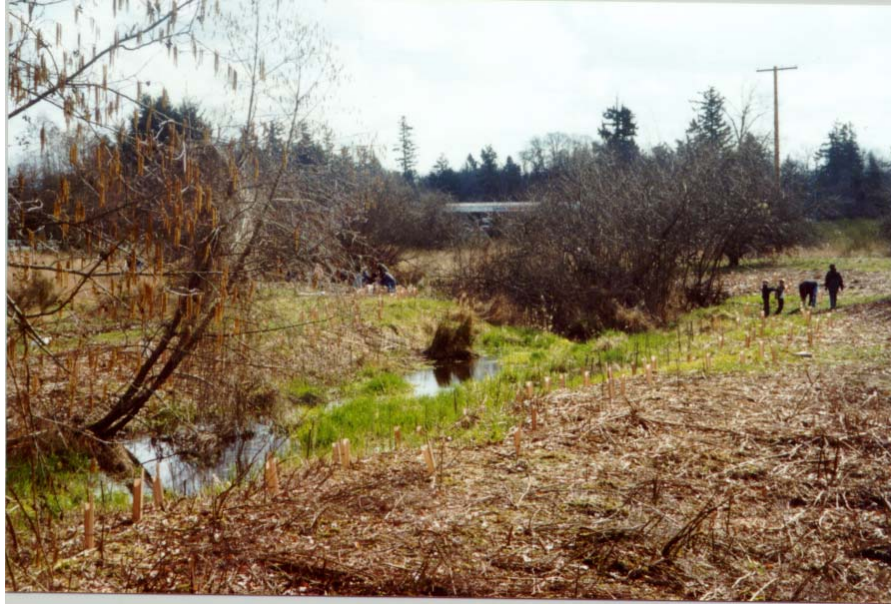
Figure 19: Planting site of riparian restoration project, March, 2000
(Photo by Pierce Conservation District)

Some riparian resoration efforts have taken place along Murray Creek (Figure 19: Planting site of riparian restoration project, March, 2000). Invasive vegetation was removed and native species were planted along a portion of the stream on Ft. Lewis property in March 2000.

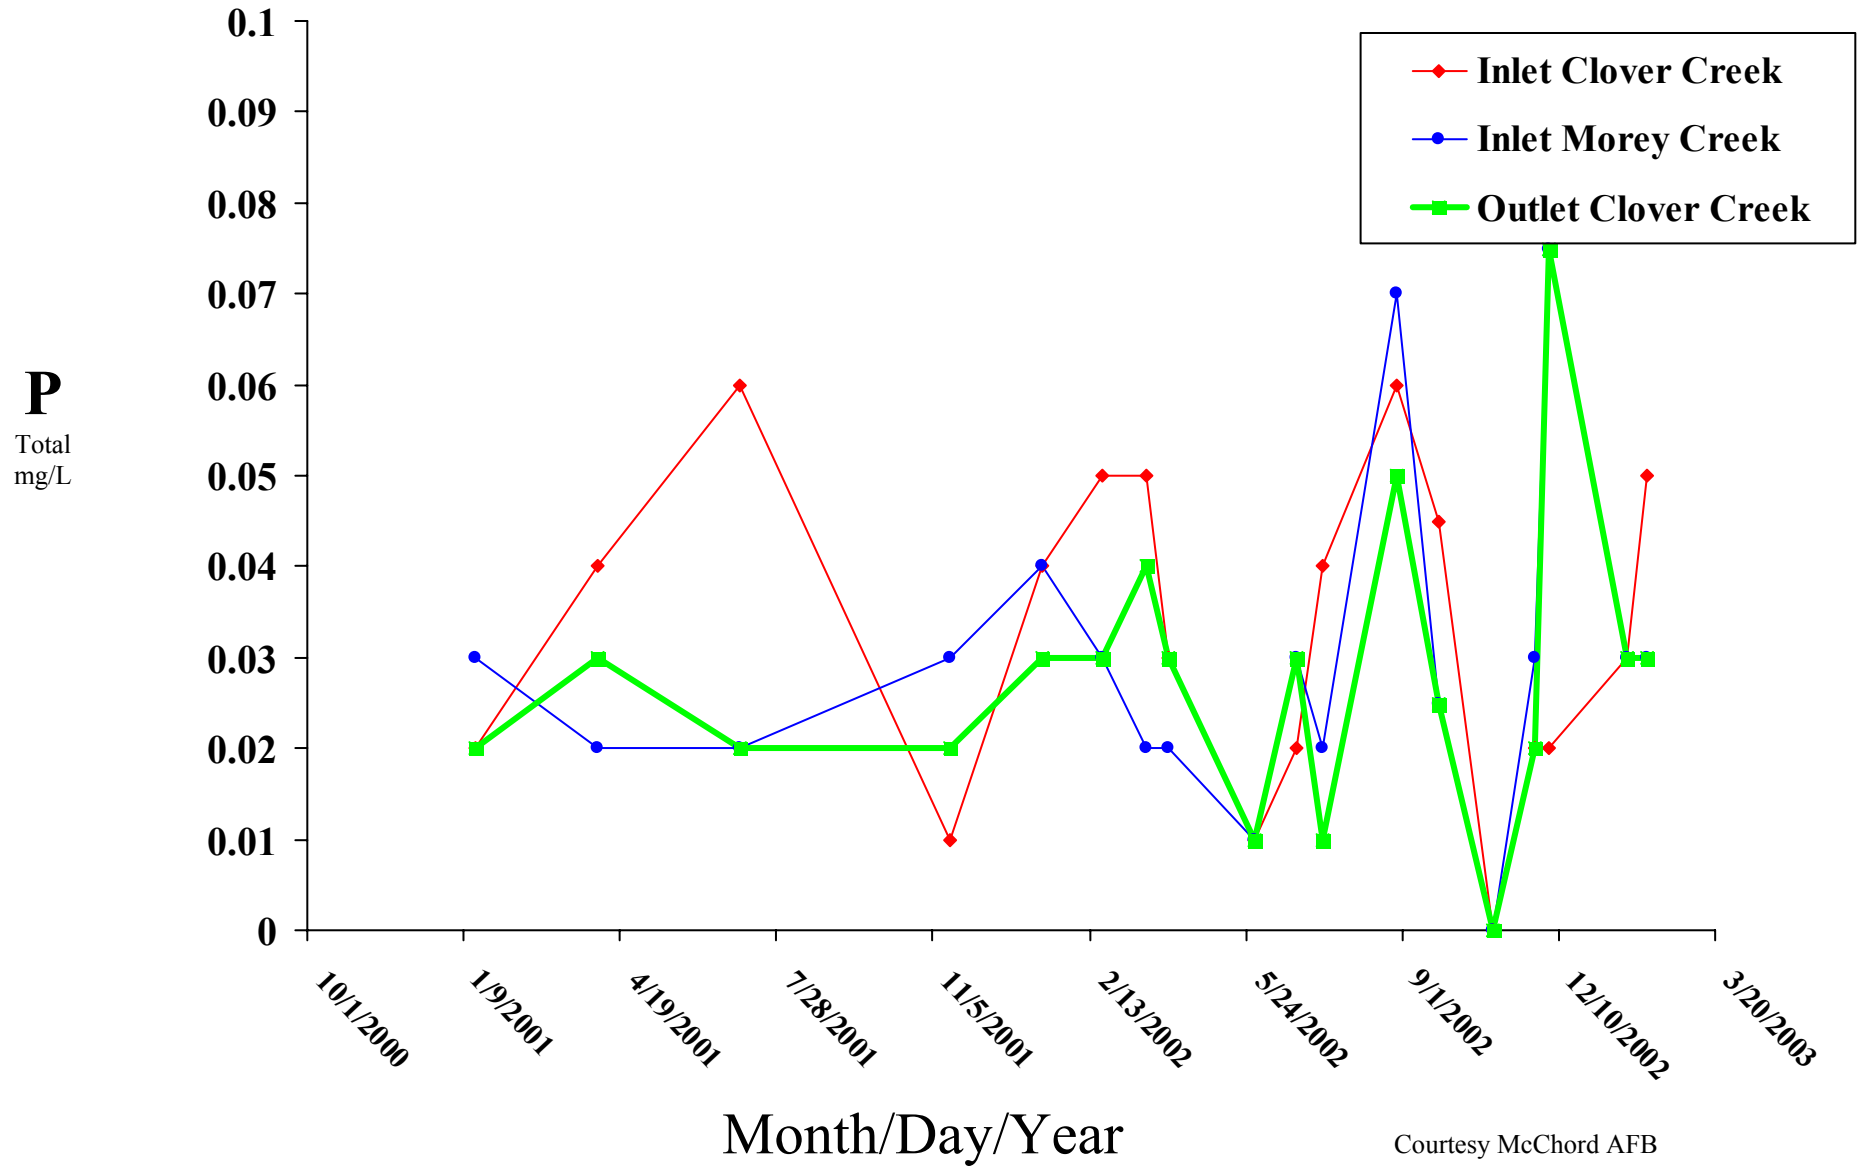
Phosphorus in Surface Water (Modified)
